From the AAIASB Report...

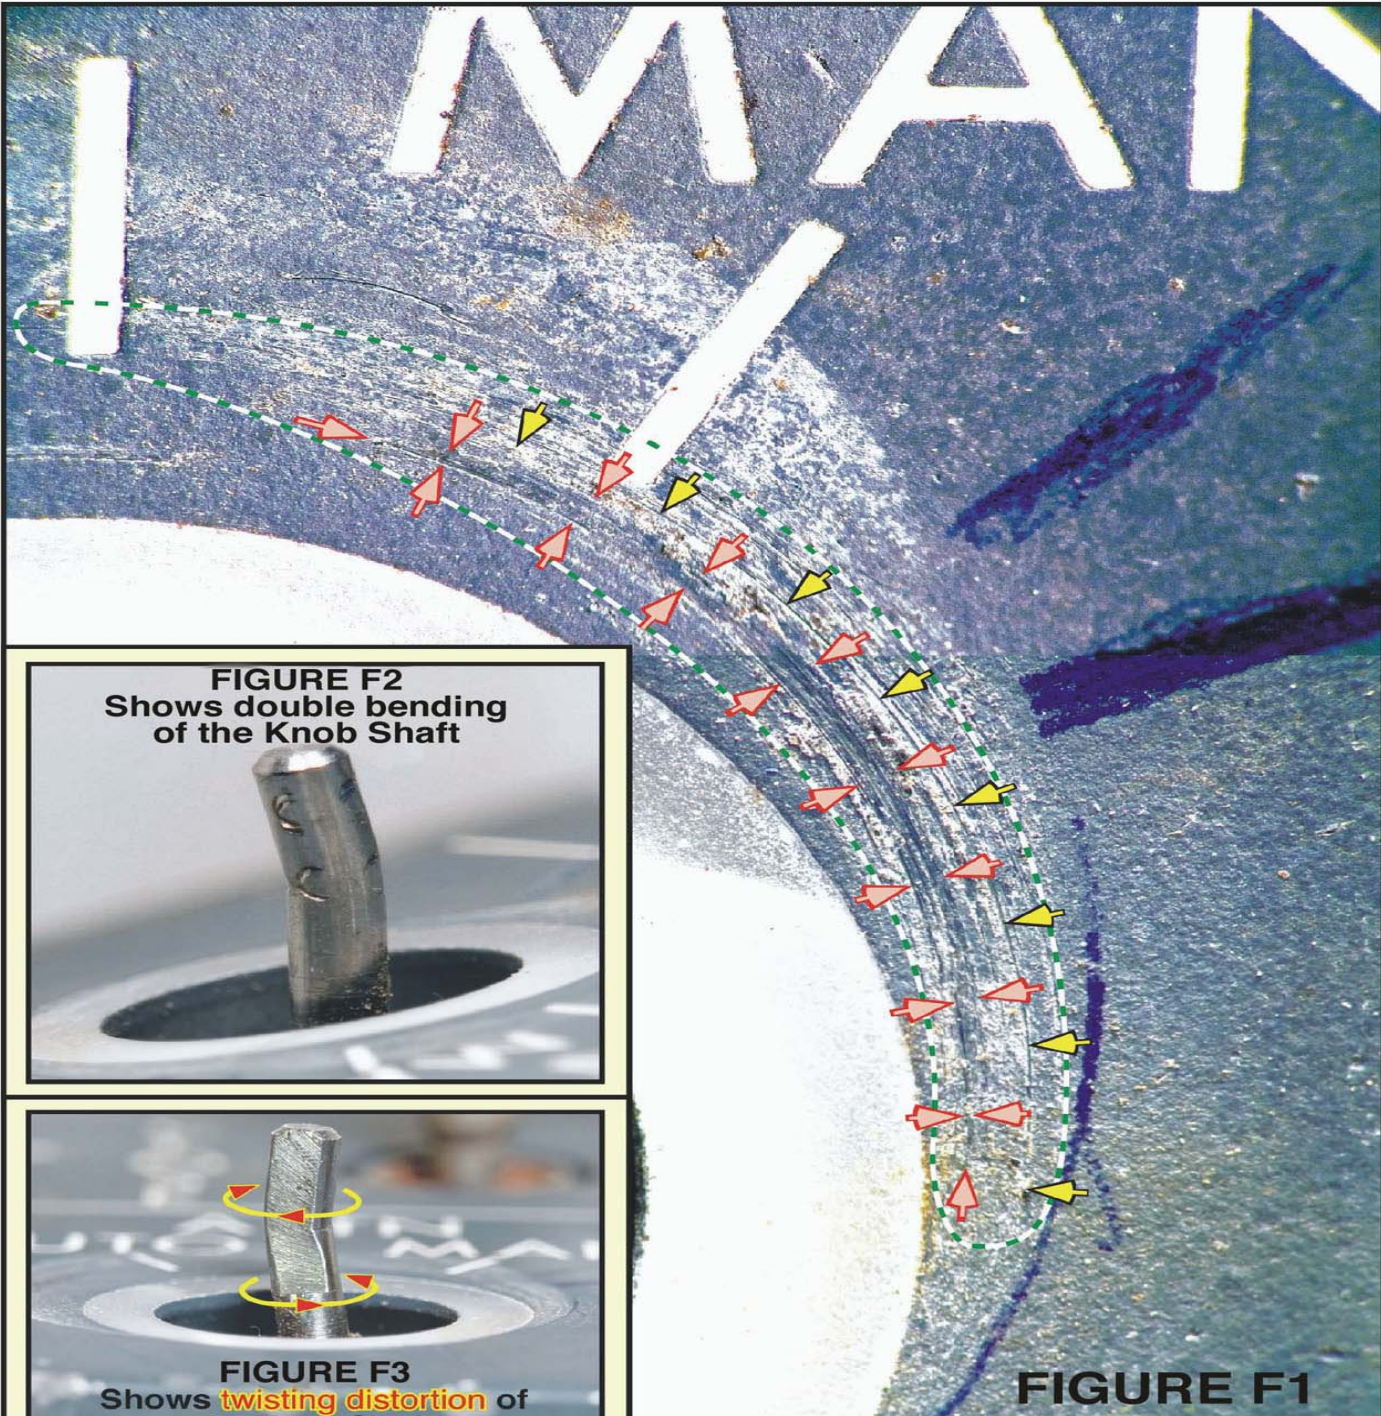
FIGURE F2
Shows double bending
of the Knob Shaft
