From the AAIASB Report...

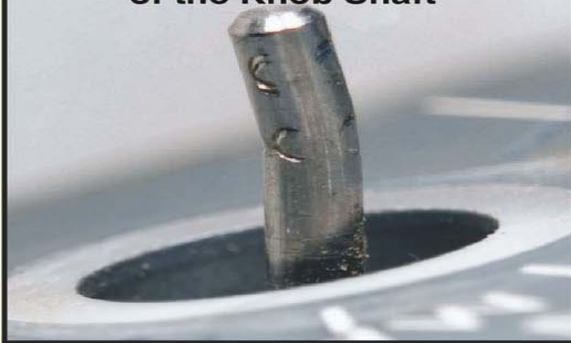
FIGURE F2
Shows double bending
of the Knob Shaft

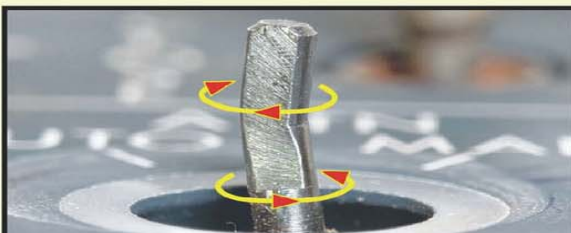
FIGURE F3
Shows **twisting distortion** of
