# From the AAIASB Report...

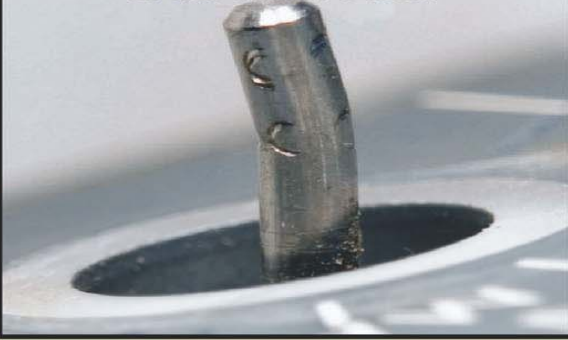
**FIGURE F2**  
Shows double bending  
of the Knob Shaft

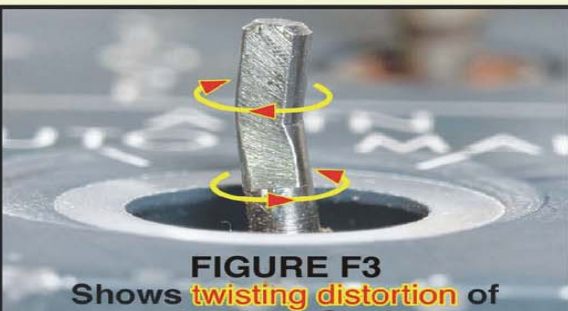
**FIGURE F3**  
Shows **twisting distortion** of
