From the AAIASB Report...

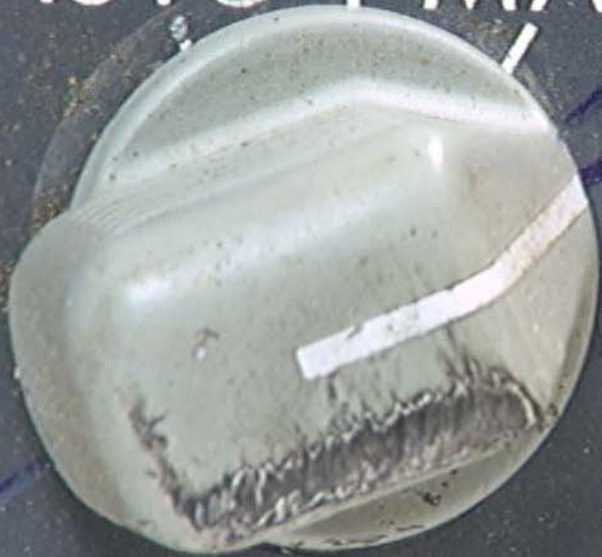
- The accident resulted from the following:
 - The Cabin Pressurization Mode Selector was left in the **MAN** position after a pressurization test
 - The Mode Selector remained in the **MAN** position during the pre-flight inspection, and throughout the flight
 - The pilots failed to recognize that the Mode Selector was in the **MAN** position – the aircraft failed to pressurize – everyone succumbed to hypoxia
